# WROUGHT IRON *for* UNDERGROUND SERVICES

A TECHNICAL BULLETIN PREPARED BY THE ENGINEERING SERVICE DEPARTMENT

**A. M. BYERS COMPANY • PITTSBURGH, PA.**

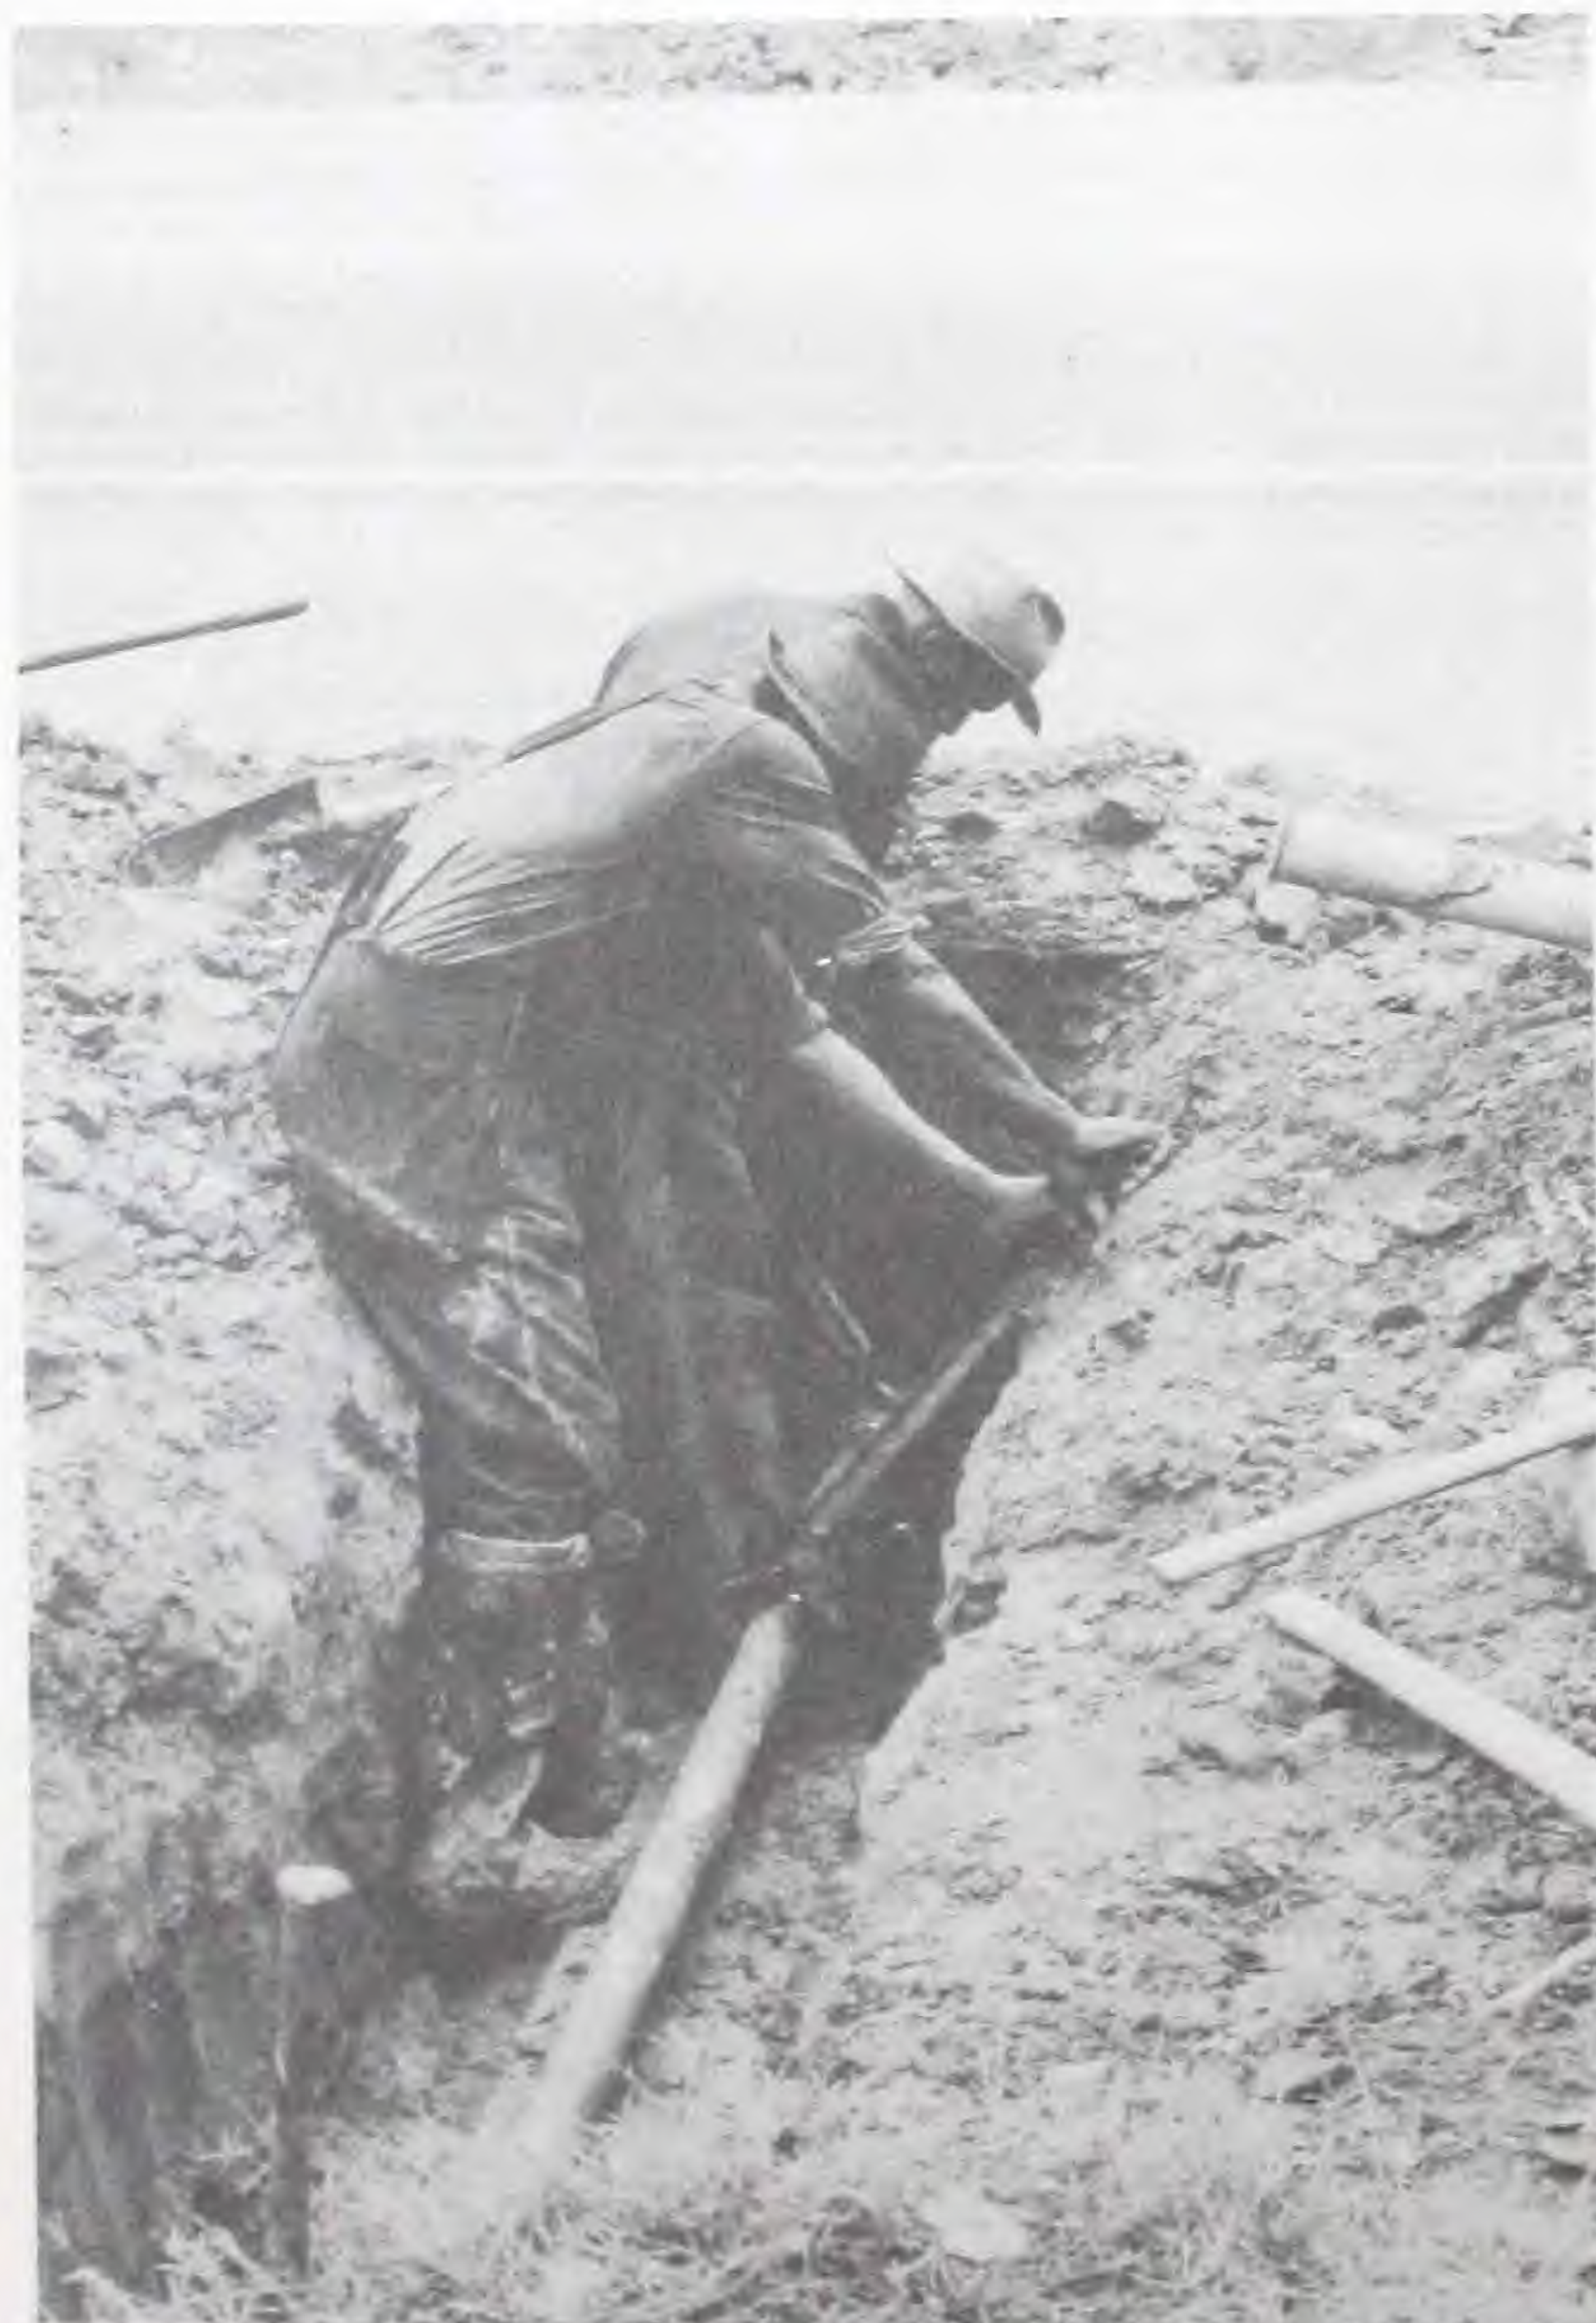
Fig. 10

We have been informed by the Superintendent of Water Supply of the City of Charlotte, North Carolina, that wrought iron is the only material in use there for water service lines  $\frac{1}{2}$ " to 3" in diameter. Figure 10 shows a new  $2\frac{1}{2}$ " galvanized wrought iron service line being installed to serve a land development along Wilkenson Boulevard. The pipe was jacked under the four-lane roadway.

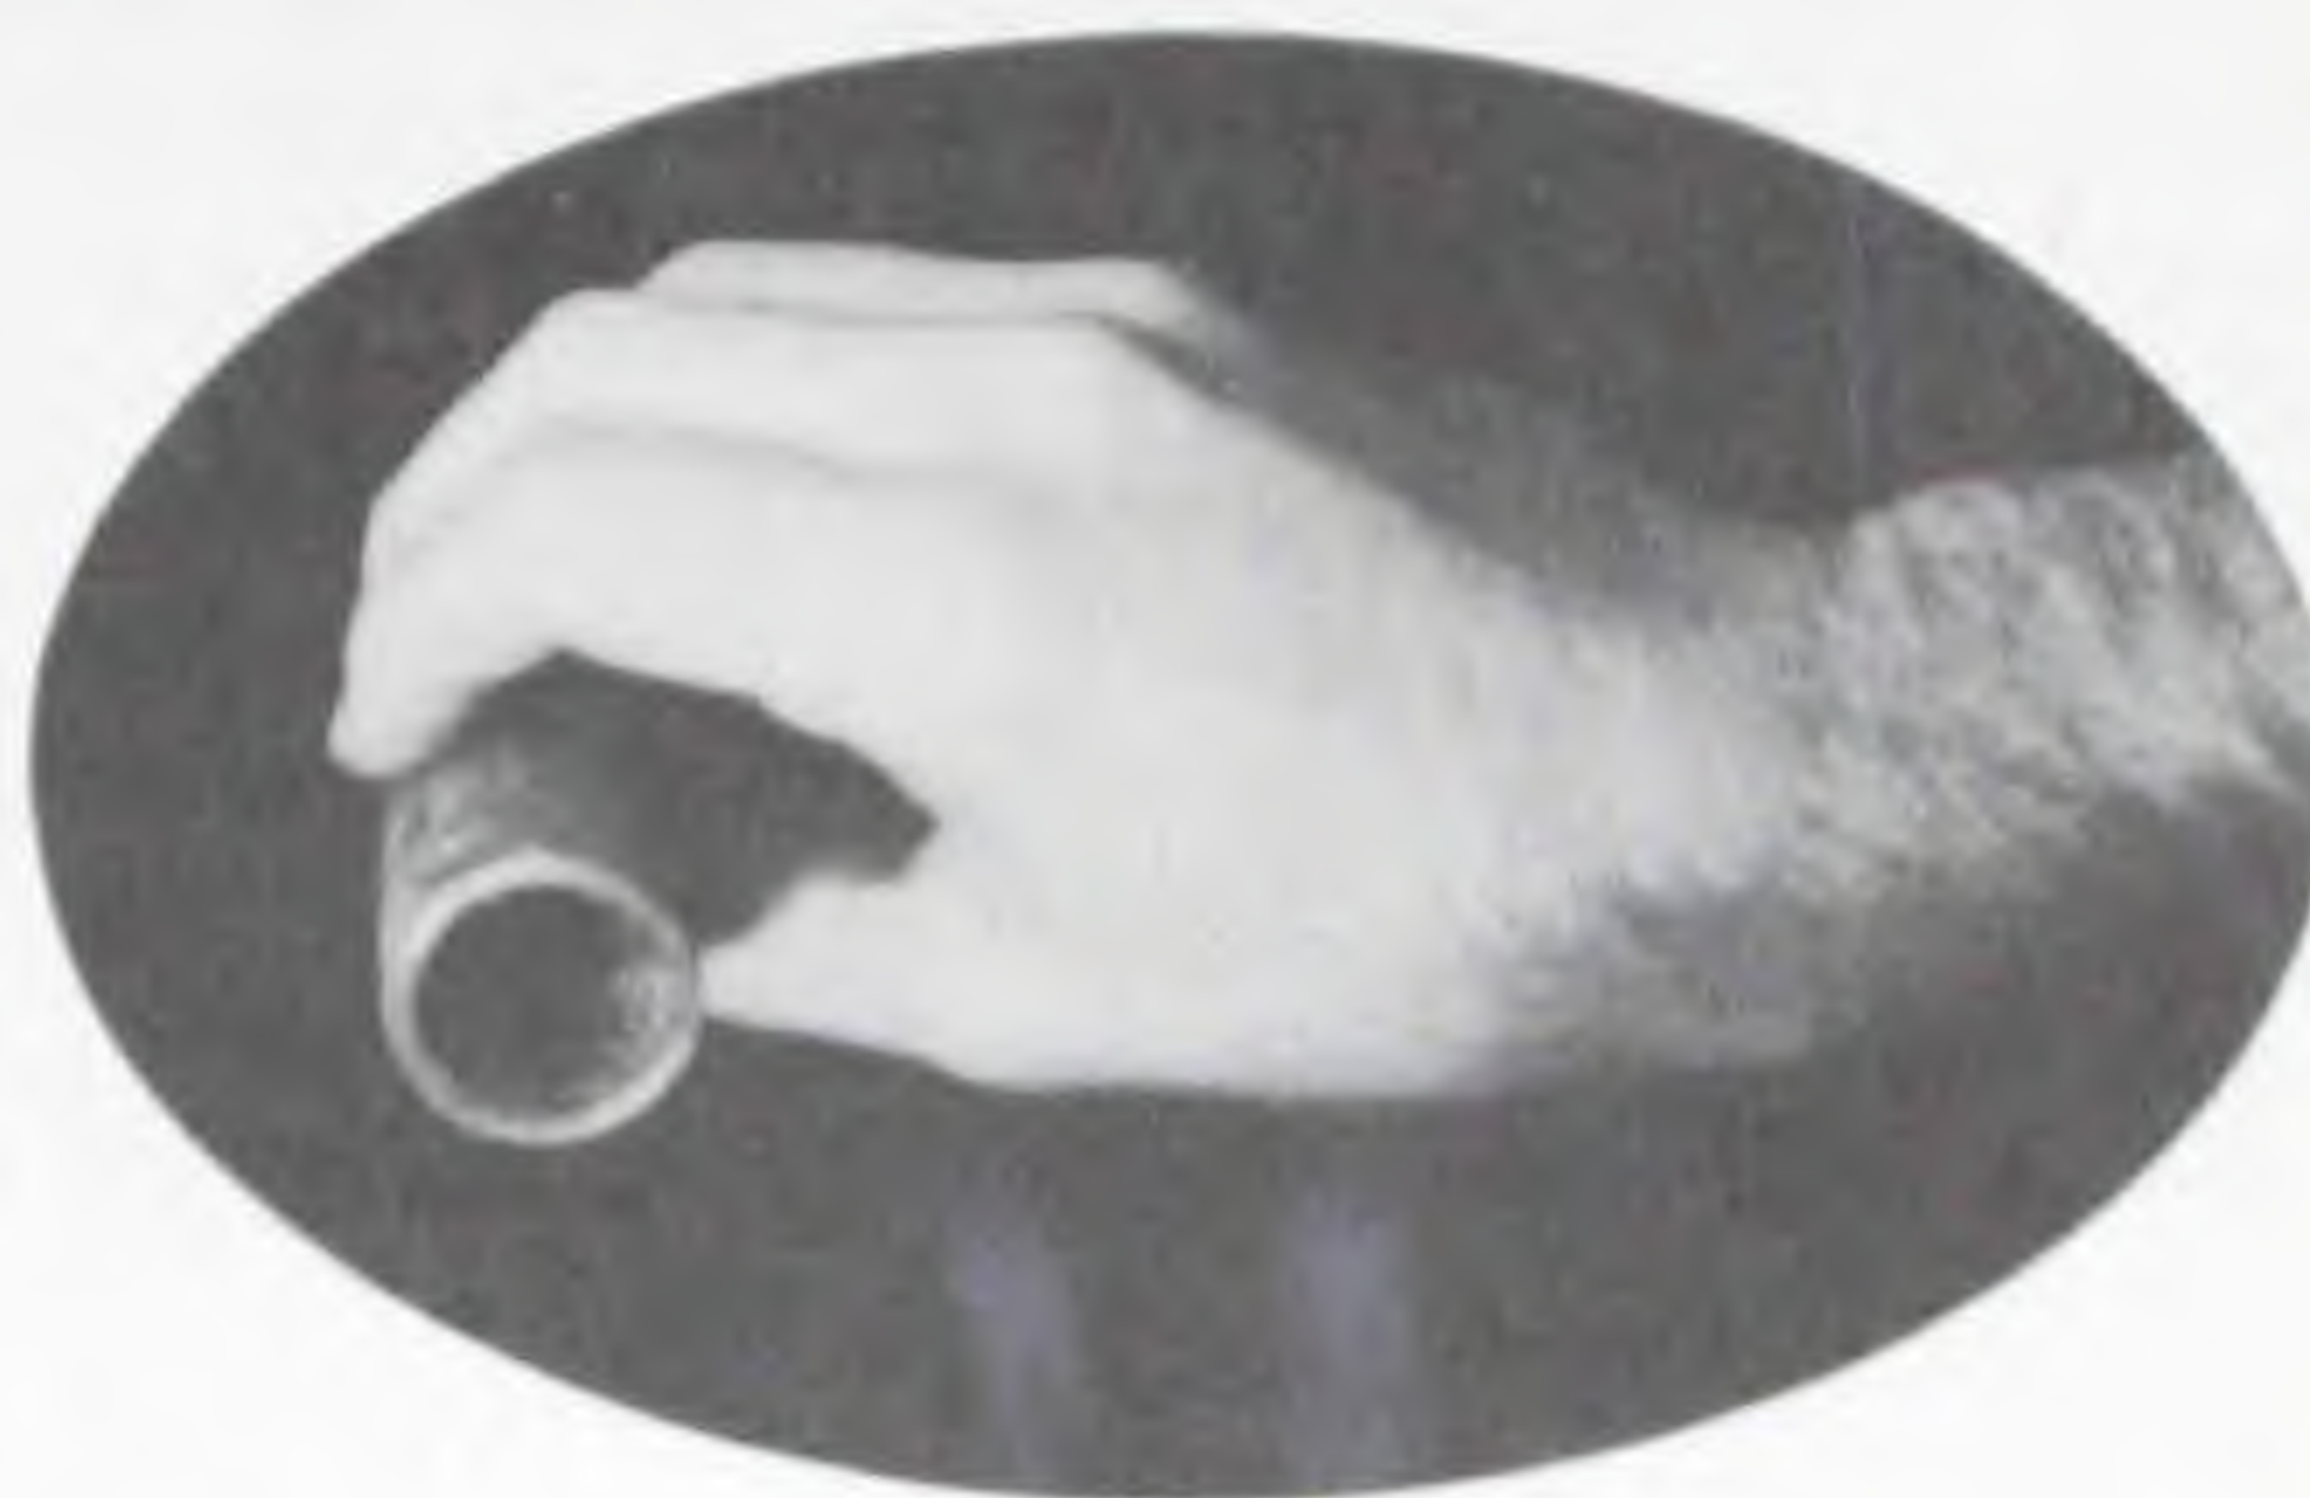
Fig. 11

An underground water line was recently removed from an estate near Stockbridge, Massachusetts and we were interested to learn that it had been in continuous service for about 70 years. The material was 1" pipe and an analysis of two samples and a coupling revealed that the material was genuine wrought iron.

Figure 11 illustrates the excellent state of preservation of the samples forwarded to us for examination.

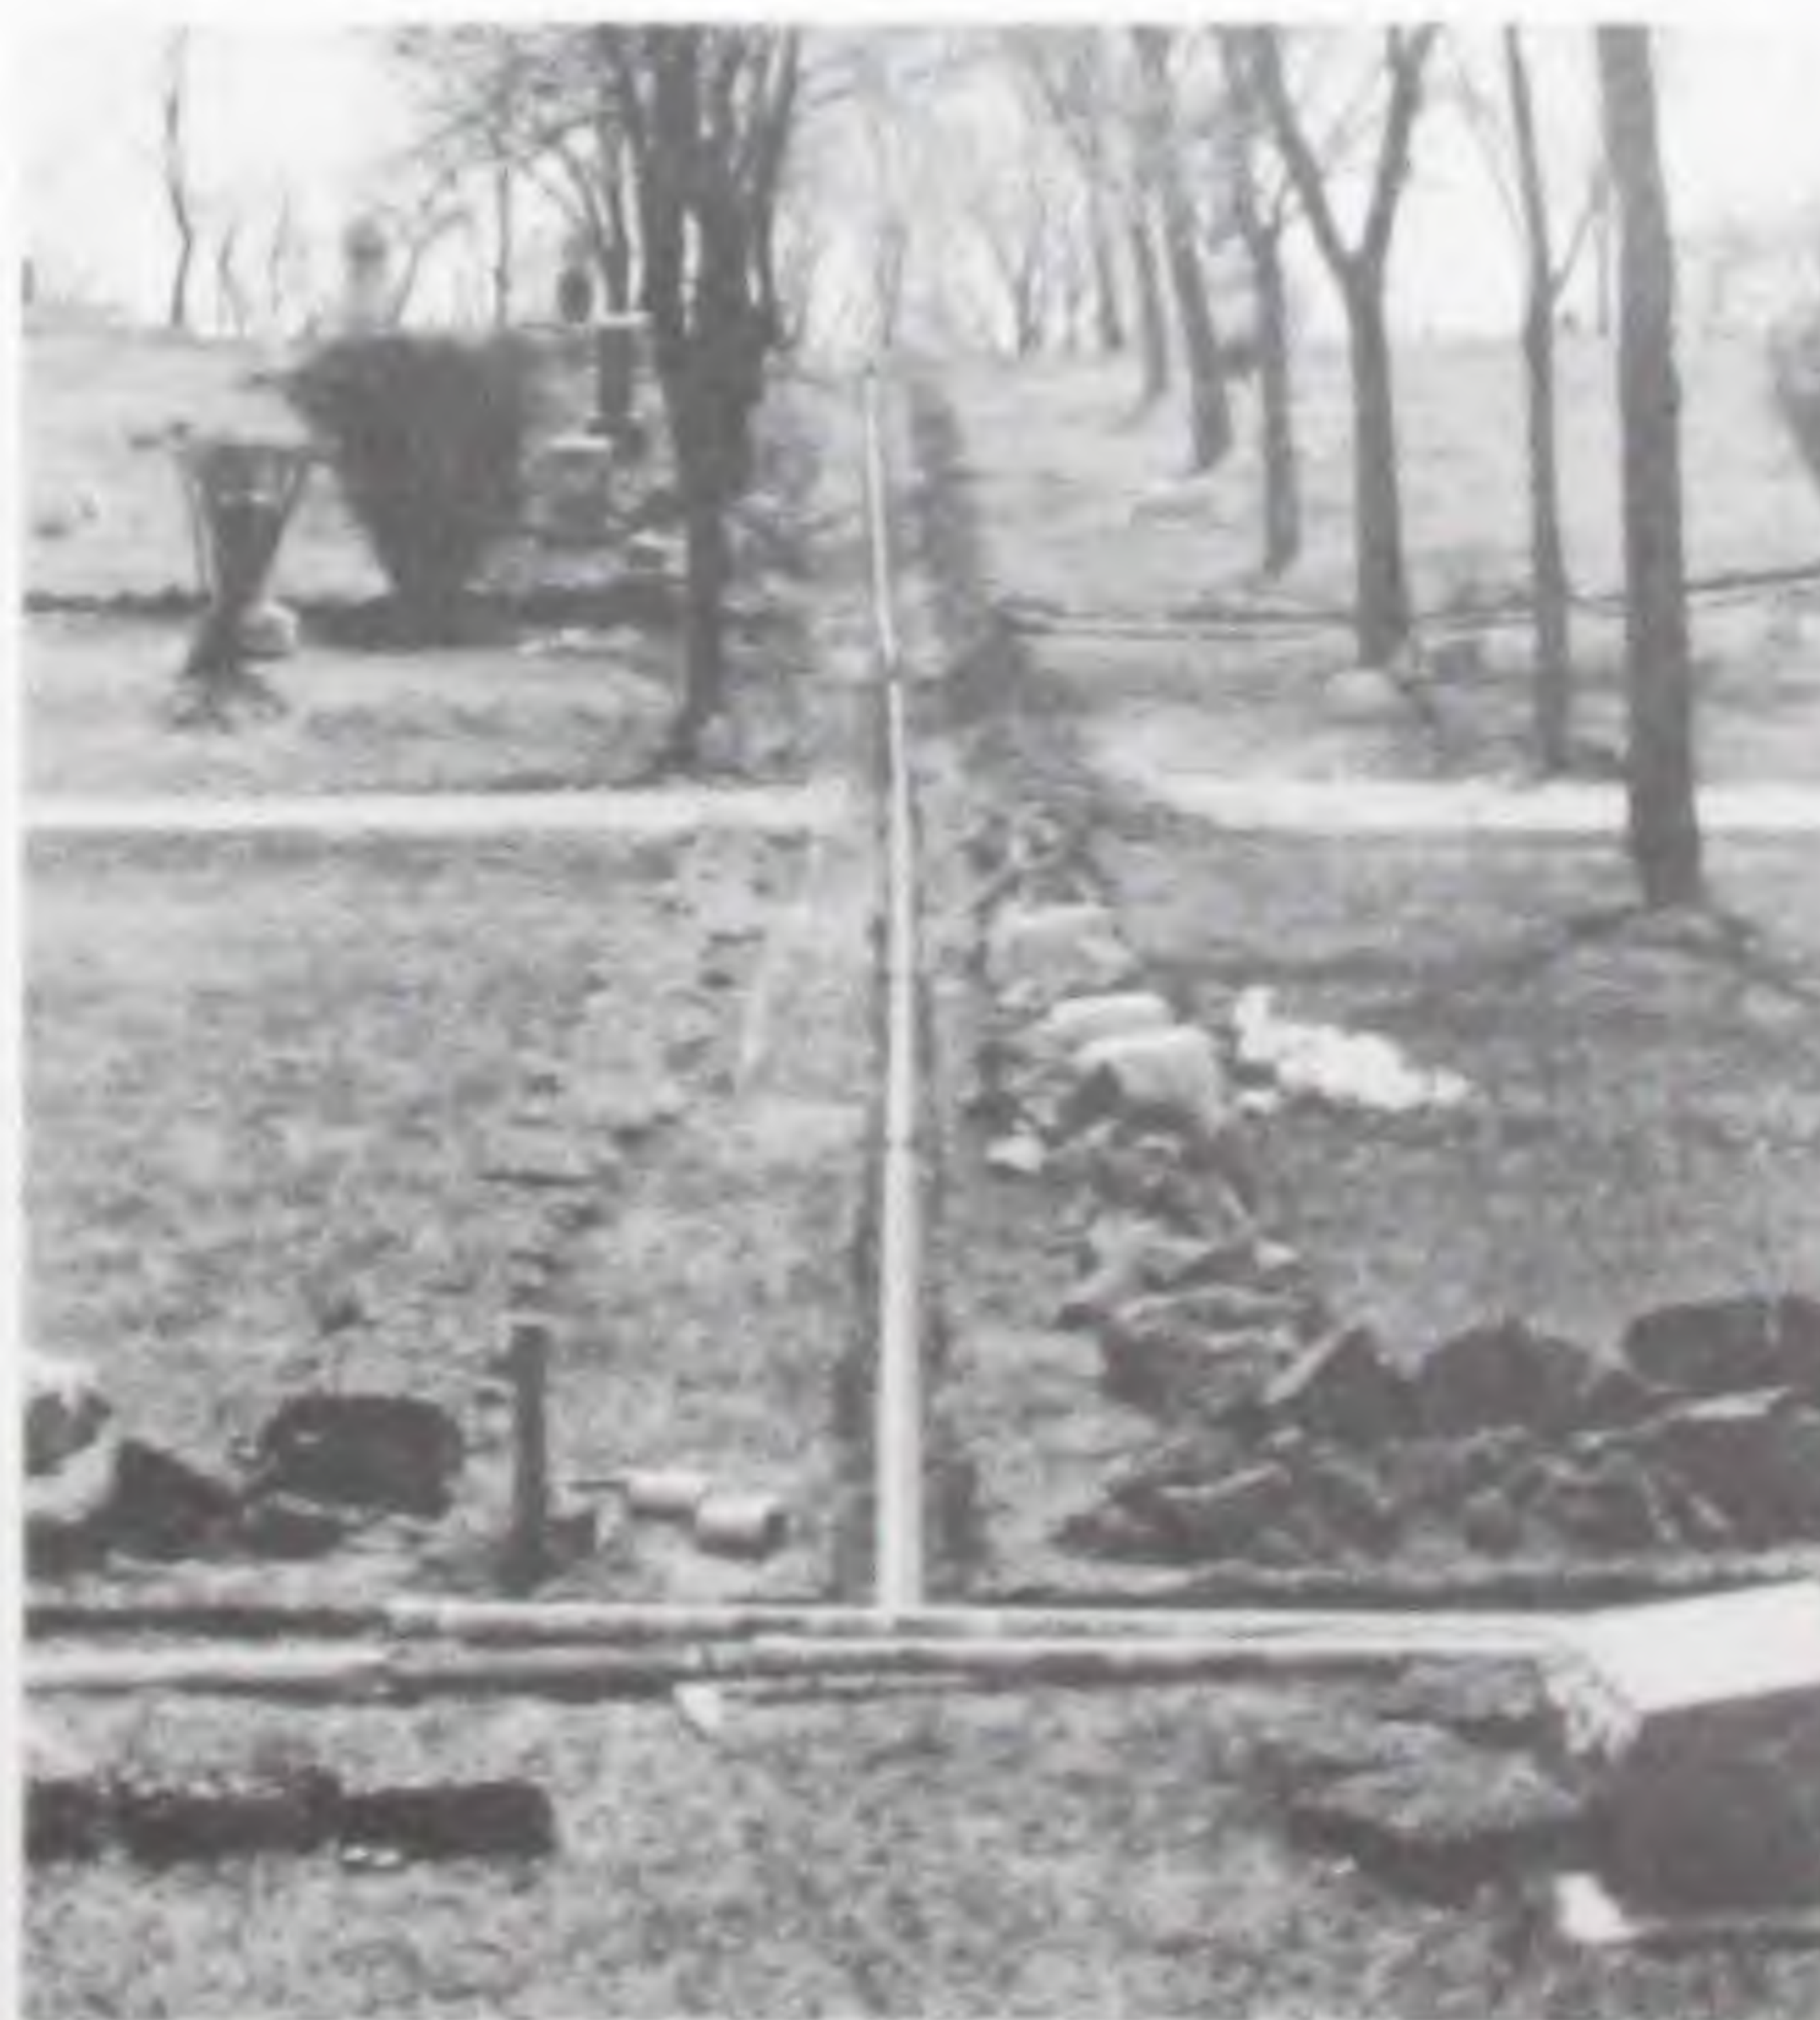
Fig. 12

At Prairie Home Cemetery, Waukesha, Wisconsin, the original sprinkling system piping was genuine wrought iron and for 43 years it gave entirely satisfactory service. When additional capacity was needed it was logical for the superintendent to select genuine wrought iron for the new piping. Figure 12 shows the new piping being installed. The old pipe, when removed, was found to be in such good condition that it was used again for other parts of the system where smaller lines were needed.

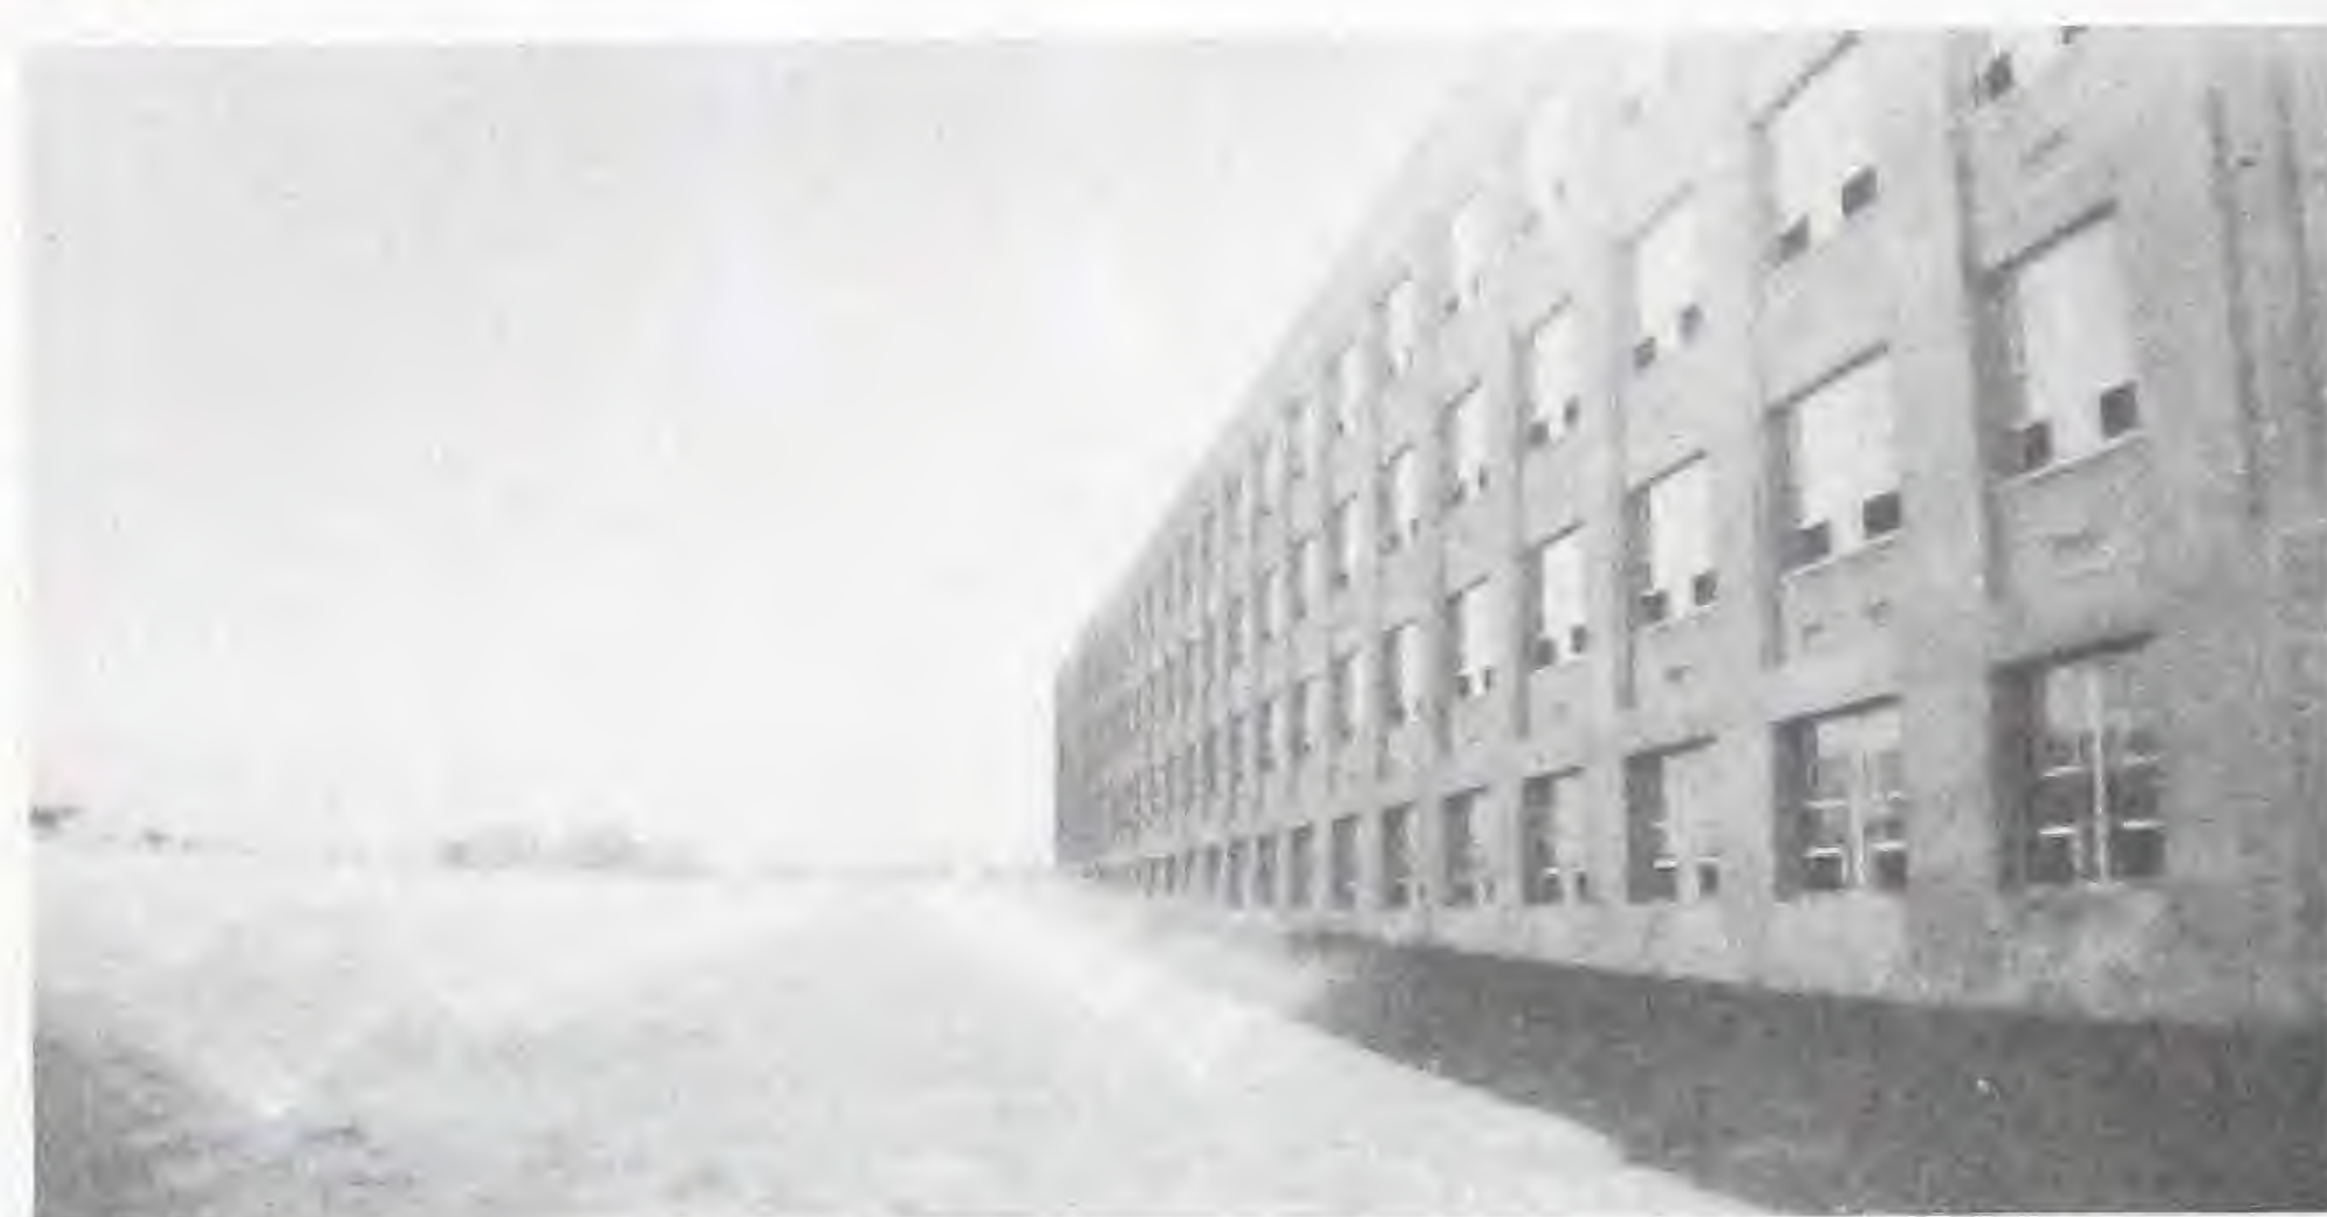
Fig. 13

At the Western Regional Research Laboratory of the U. S. Department of Agriculture, Albany, California, a lawn sprinkling system was recently installed, using wrought iron pipe. Figure 13 shows the system in operation.

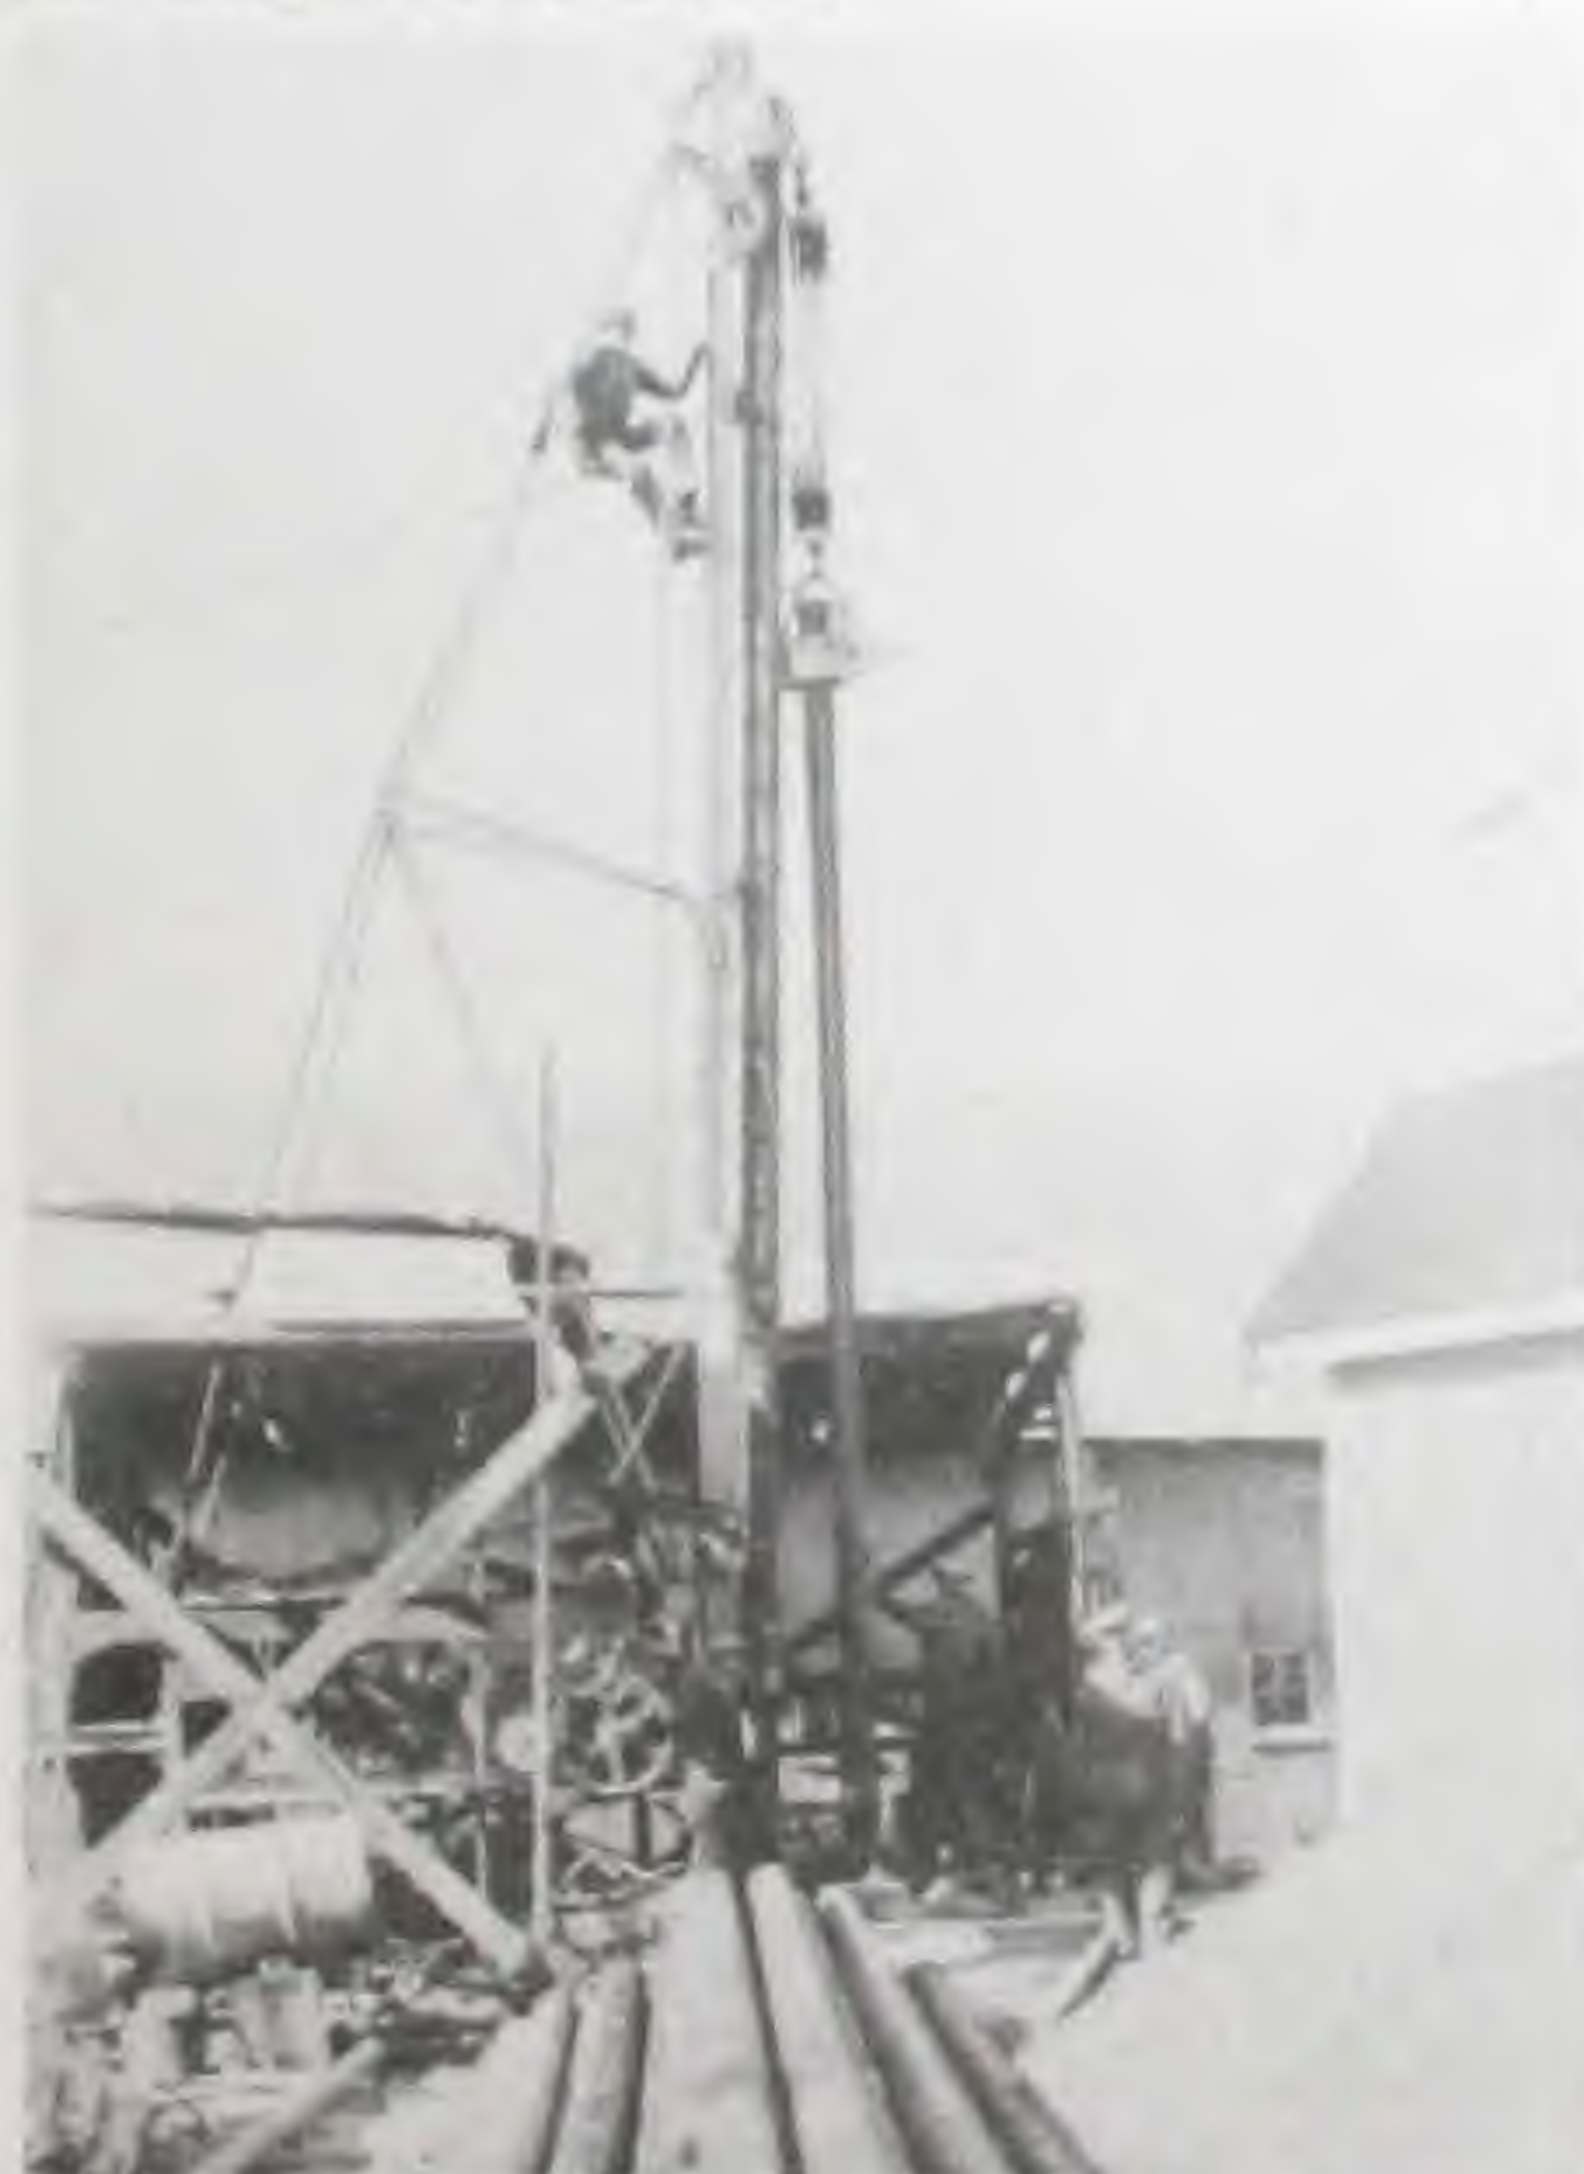
were used. Fig. 15 shows casing being installed in this well.

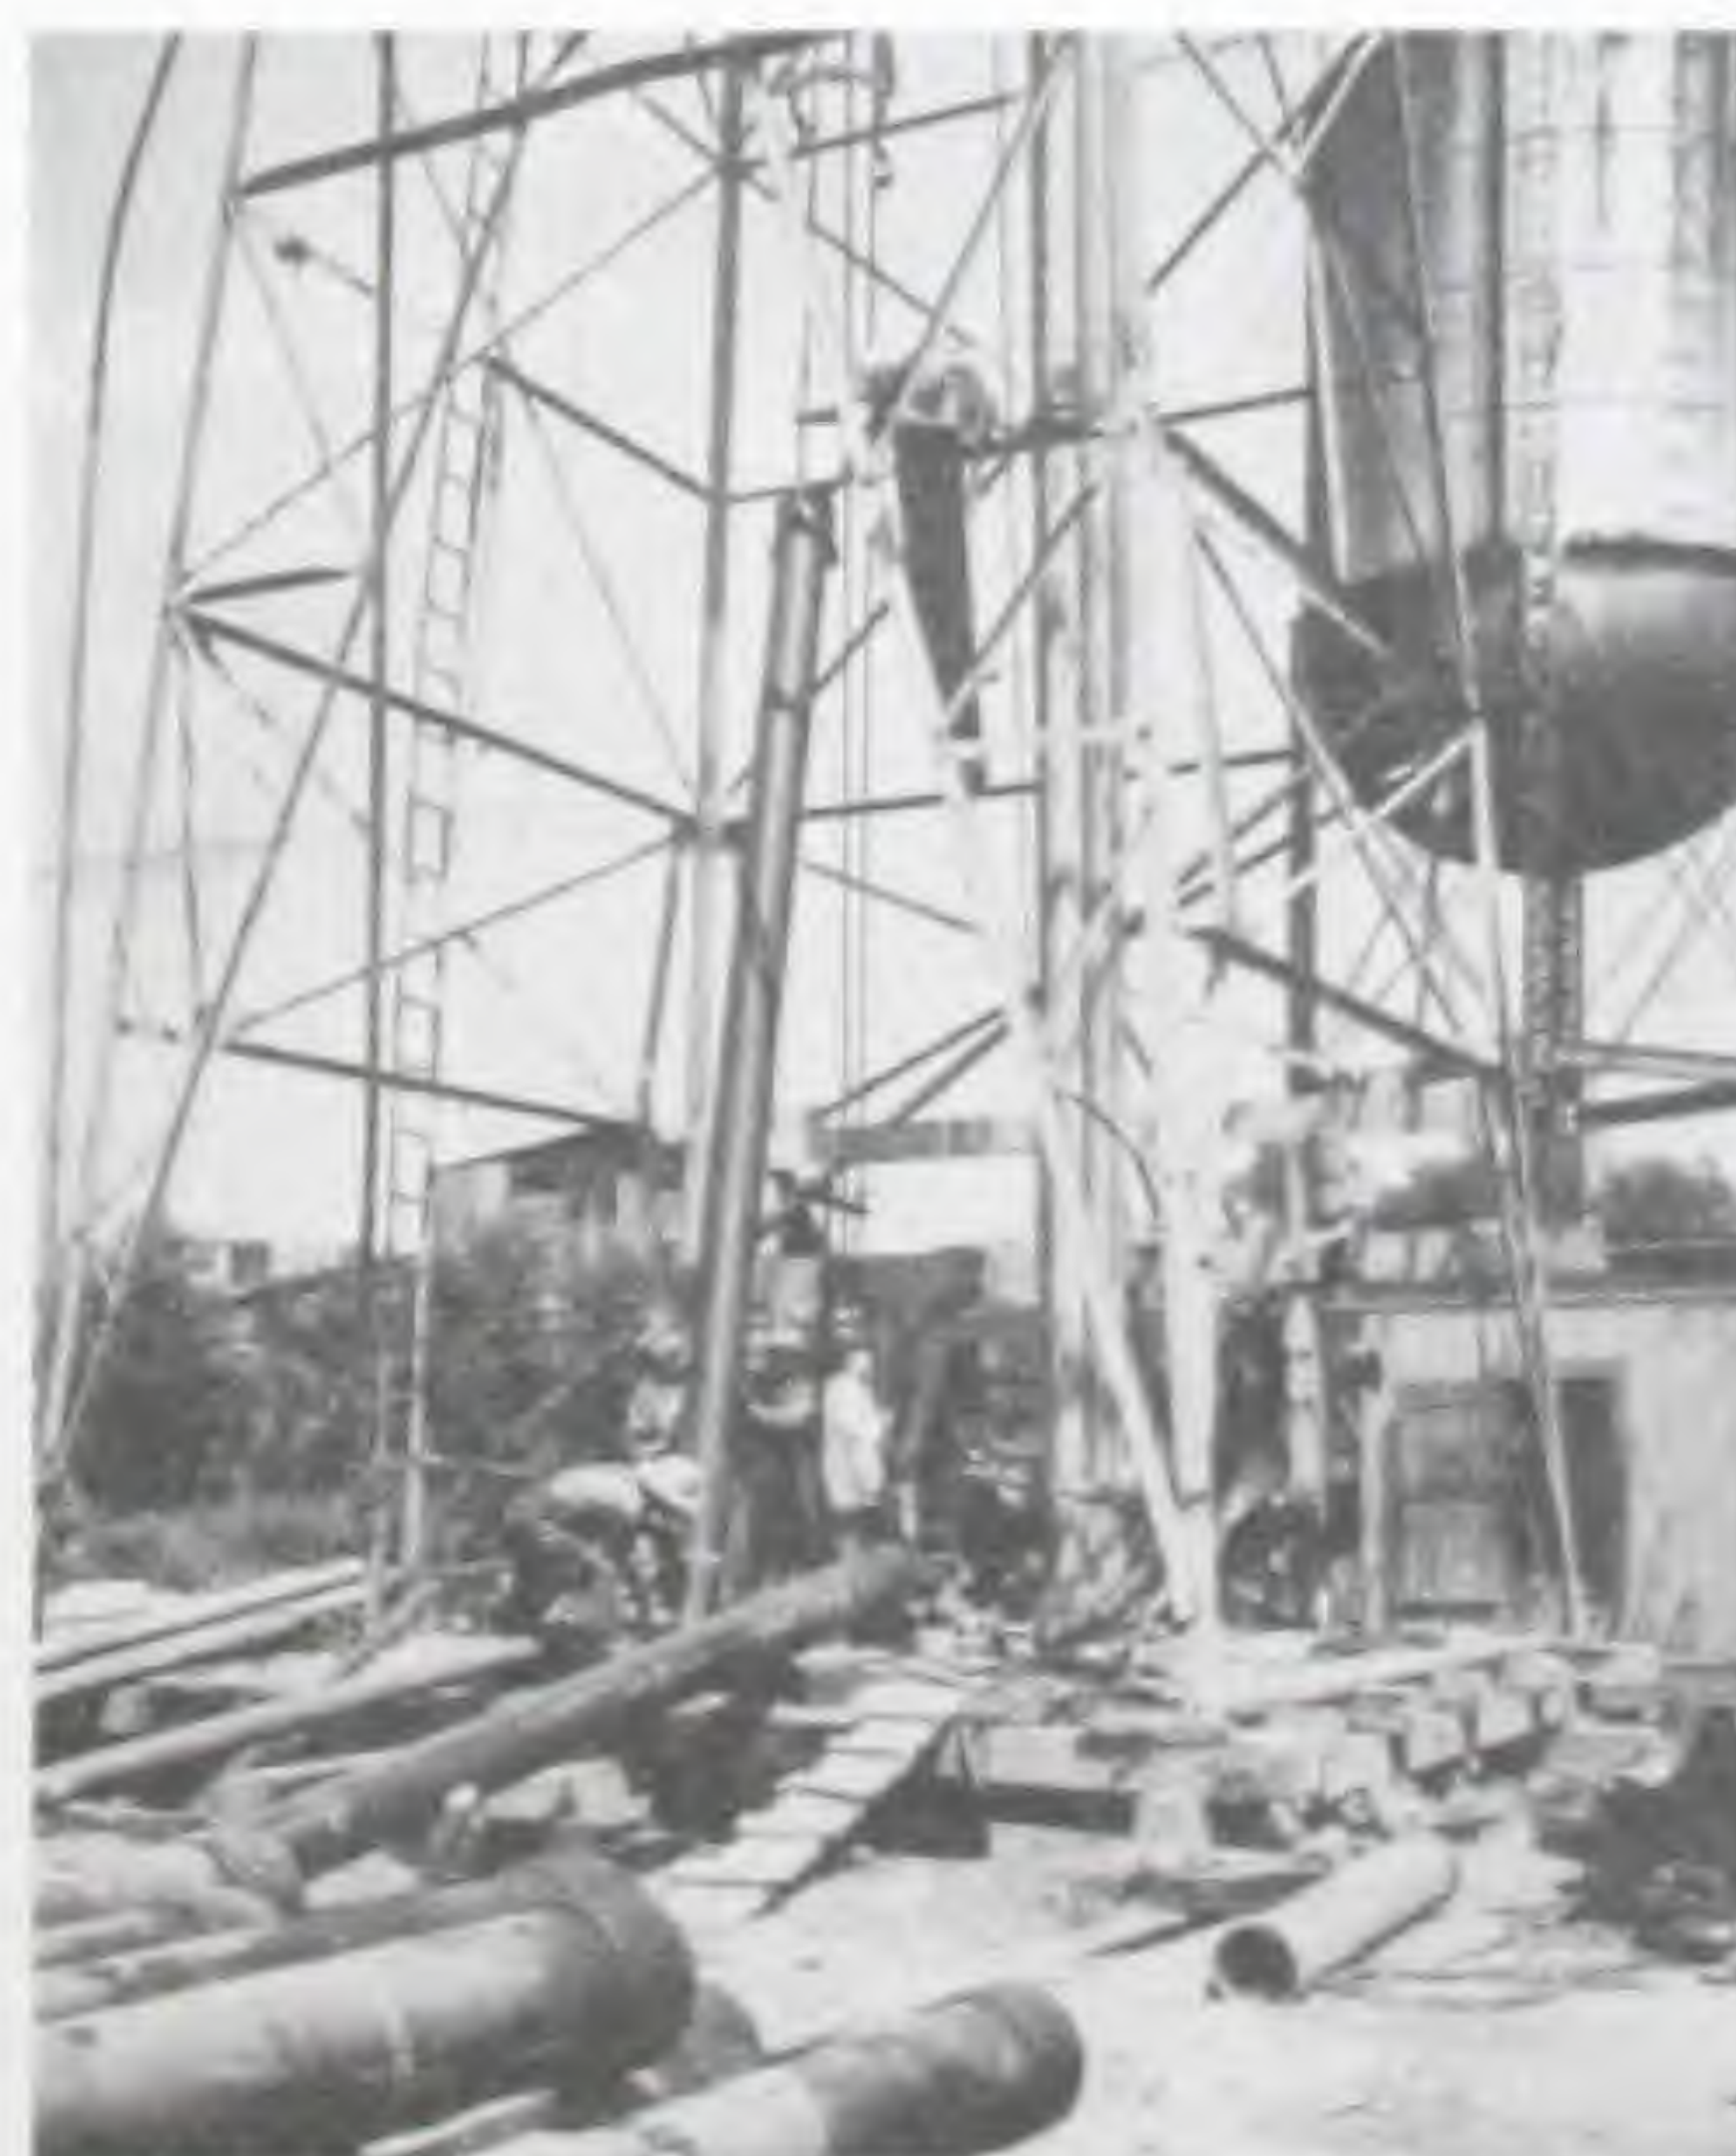
Fig. 17

Figure 17 shows Byers 10"—32.75 lb. black wrought iron casing being run into a deep well at the Houston, Texas, Roundhouse of the Houston Belt and Terminal Railway Company. Approximately 25 tons of casing were required for this well.
